MOUSAM RIVER BASIN  
SANFORD, MAINE

RIVER STREET DAM  
ME-00184

PHASE I INSPECTION REPORT  
NATIONAL DAM INSPECTION PROGRAM

OCTOBER 1978

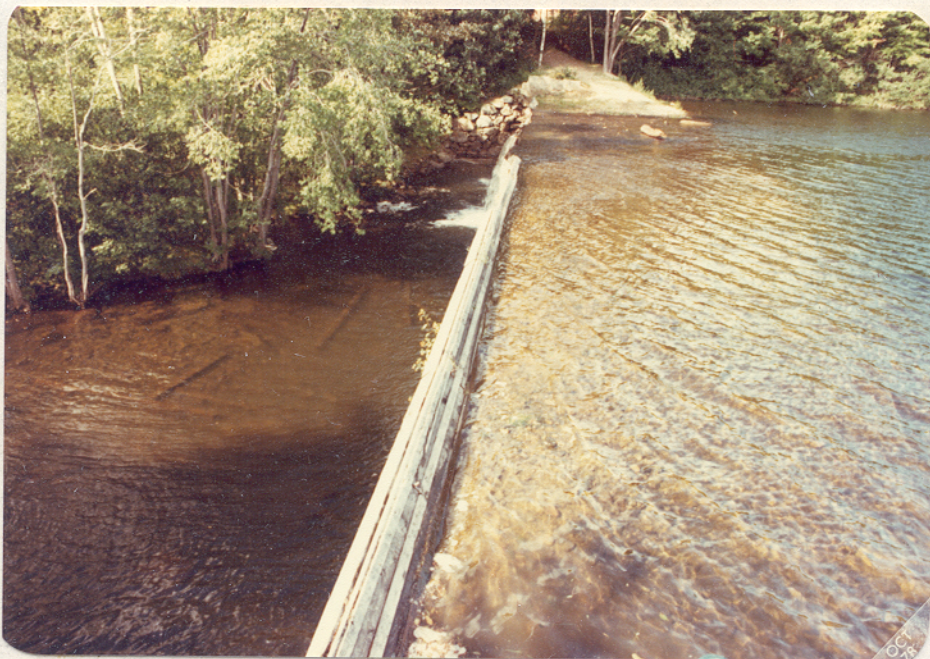
1

TOP OF DAM WESTERLY VIEW

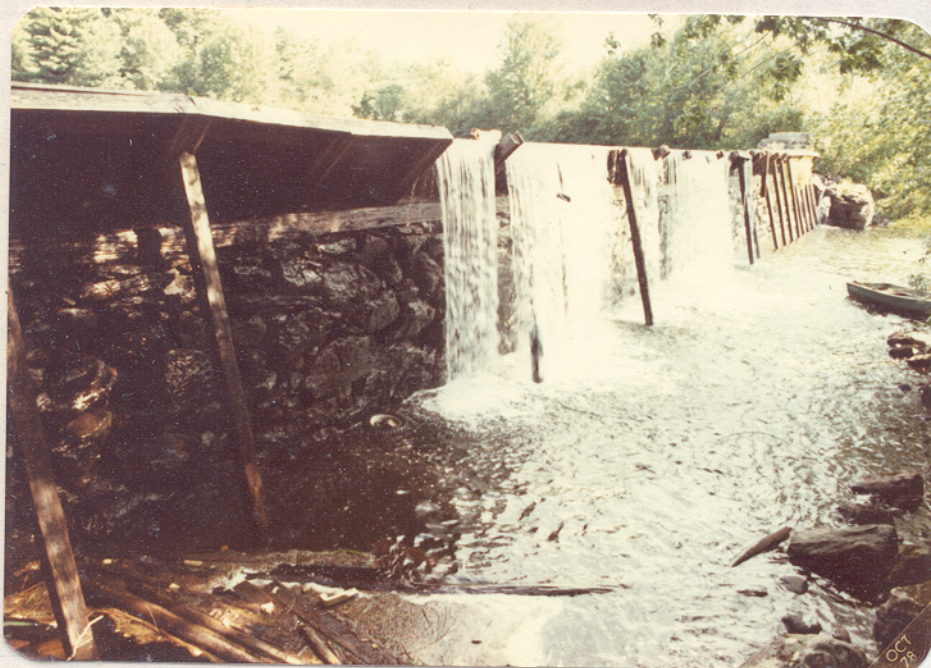
2

BASE OF DAM EASTERLY VIEW

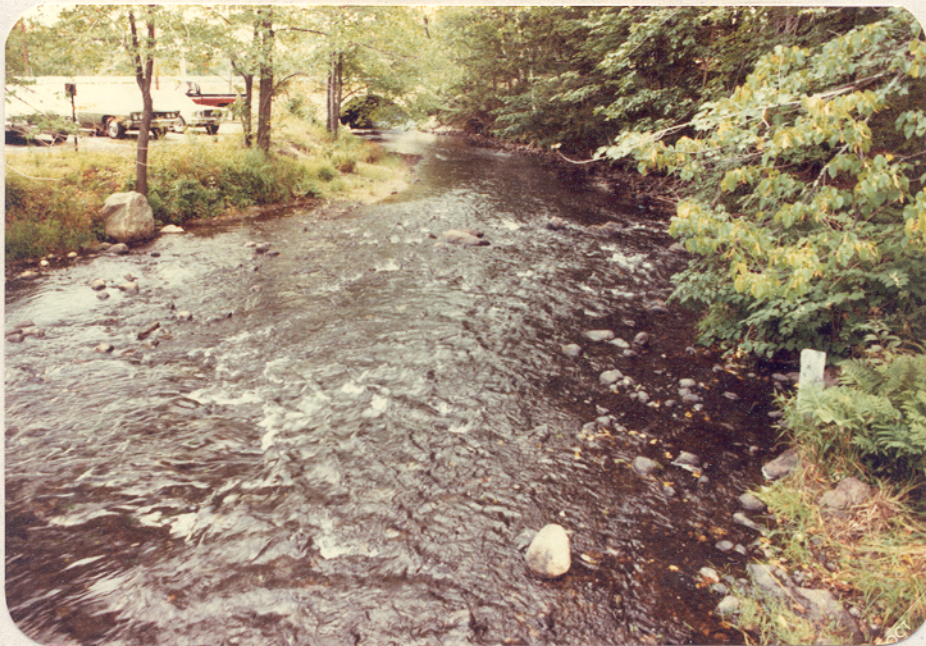
3

- c. Approach and Outlet Channels - The approach channel to the timber spillway and the planked gated spillway both appear to be clear and unobstructed. See photograph 5. The outlet channel was found to be clear and unobstructed. See photograph 3. The stilling basin consists of a stone lined channel below the dam.

DOWNSTREAM CHANNEL, BELOW DAM, SOUTHERLY VIEW

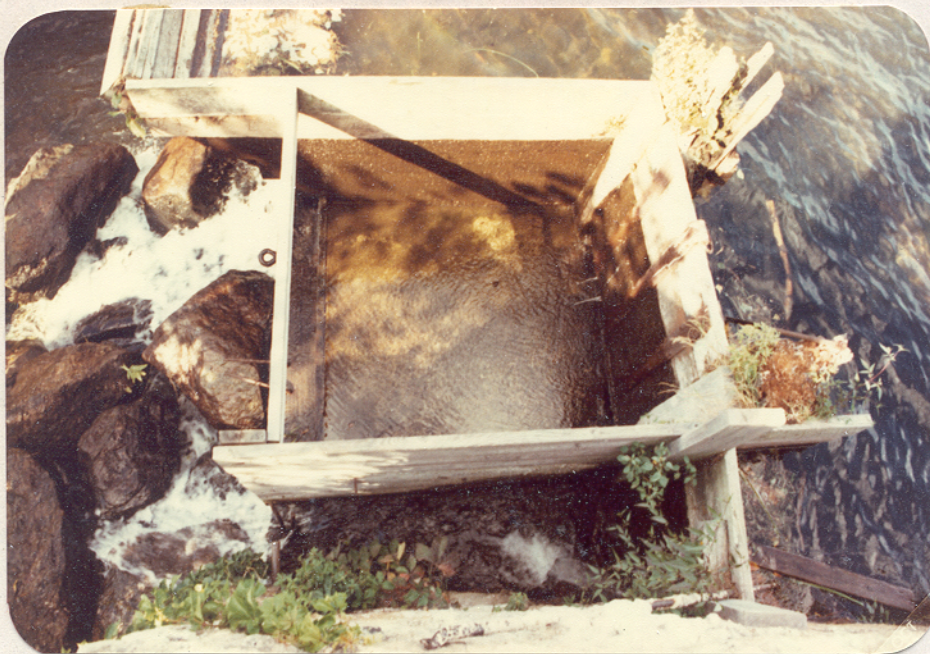
There appears to be a low level control outlet located in the easterly portion of the dam. This outlet is closed, no water was found to be flowing through the outlet. There were no means to open this outlet observed at the dam. A detailed inspection of this outlet could not be made due to water level in the impoundment.

OLD GATE, EAST END OF DAM

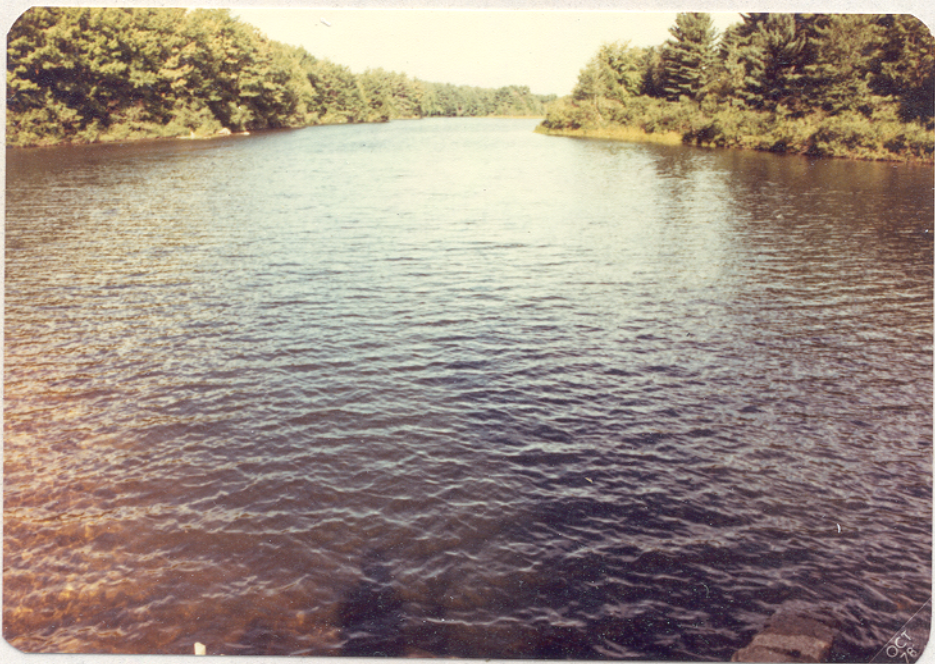
5

UPSTREAM VIEW, NORTHERLY DIRECTION
